Okemos Public Schools

2022 Bond Proposal

Steering Committee #4

February 23, 2022

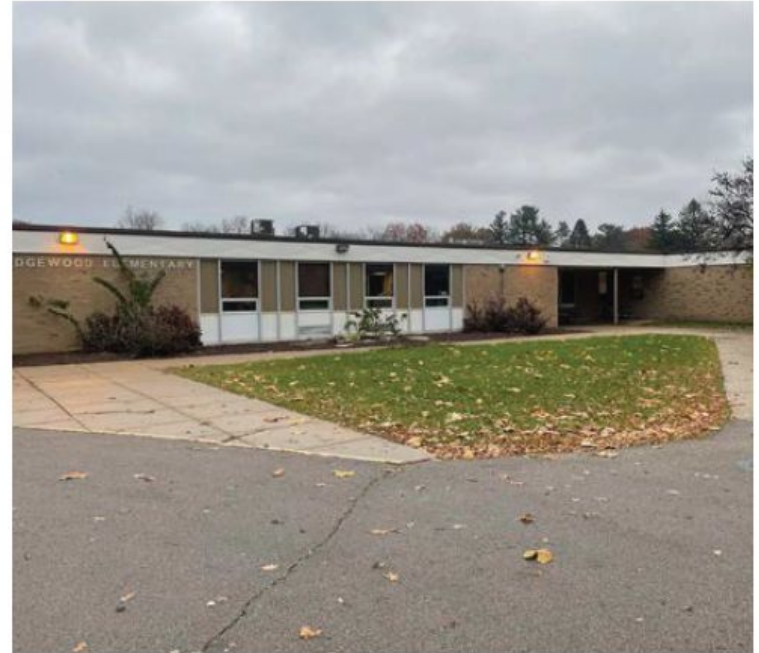
01 EDGEWOOD ECC

Use:	Childcare / Pre-School
Built:	1963
Additions + Renovations:	1966 / 1978 / 1988
Total Building Area:	33,000 SF
Site Area:	12 Acres
Enrollment:	65 students
Square Footage per Student:	508 sf/student
Renovation Cost:	\$9,760,517
Current Replacement Value [CRV]:	\$10,560,000
Facility Condition Index [FCI]:	92%

- Poor vehicular circulation; sidewalks and playground need replacement
- Water issues and accessibility improvements needed at corner porches
- Storage addition and gas building need demolition and replacement
- Office space inadequate, many interior spaces without natural light
- Windows, doors, roof, floor finishes, suspended ceilings, and casework need replacement
- Lighting and mechanical systems need replacement

- **FCI 92%** - Significant renovations needed to reach “good” rating - not a good candidate for significant investment

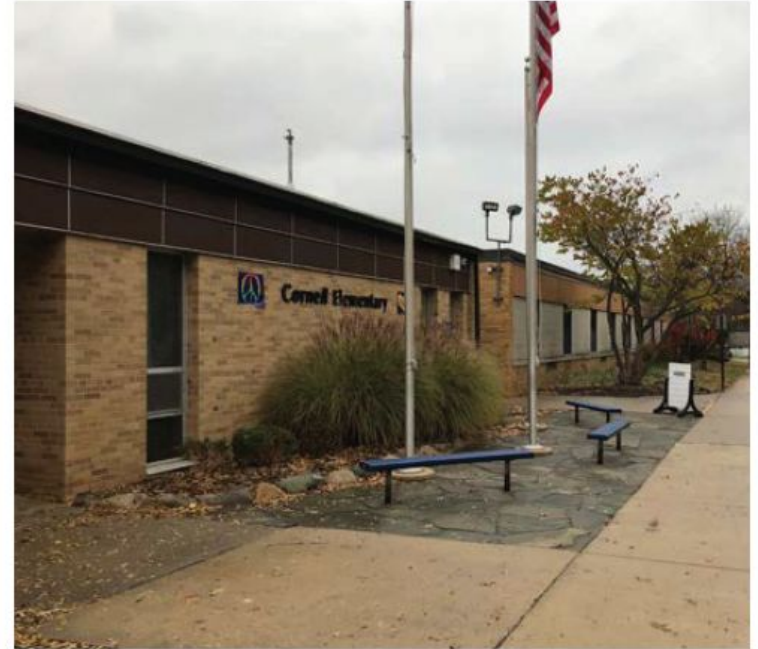
02 CORNELL ELEMENTARY

Use:	K-4
Built:	1955
Additions + Renovations:	1958 / 1977 / 1988
Total Building Area:	43,000 SF
Site Area:	10 Acres
Enrollment:	437 students
Square Footage per Student:	98.4 sf/student
Renovation Cost:	\$14,322,352
Current Replacement Value [CRV]:	\$13,760,000
Facility Condition Index [FCI]:	104%

- Not enough space for parent drop off/pick up, inadequate service entrance
- Exterior fascia and roof need replacement, brick repairs needed
- Flooring and casework need replacement
- Corridors narrow, office/staff support space inadequate, lacks collaborative space
- Replace lighting throughout, mechanical units and controls need replacement
- Overhead power lines to building are too low

- **FCI 104%** - Significant renovations needed to reach “good” rating - not a good candidate for significant investment

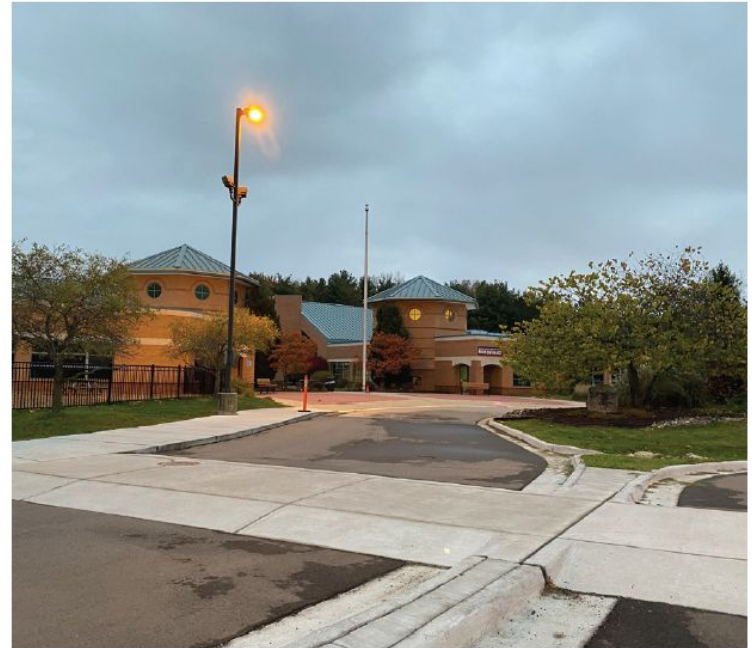
03 BENNETT WOODS ELEMENTARY

Use:	K-4
Built:	1993
Additions + Renovations:	2019
Total Building Area:	60,800 SF
Site Area:	45 Acres
Enrollment:	469 students
Square Footage per Student:	129.6 sf/student
Renovation Cost:	\$10,404,391
Current Replacement Value [CRV]:	\$19,456,000
Facility Condition Index [FCI]:	53%

- Conflict with parent drop off/walkway from parking lot
- Screen wall at loading dock needs replacement, inadequate service entrance
- Sloped glazing system enclosure and brick base is failing
- Exterior doors need repair/replacement
- Flooring and ceilings need replacement, casework needs repair

- **FCI 53%** - Minor to moderate renovations recommended to reach “good” condition
 - good candidate for renovations
- Age of the building is relatively young; recent site improvements, interior renovations, and additions increased capacity/extended useful life

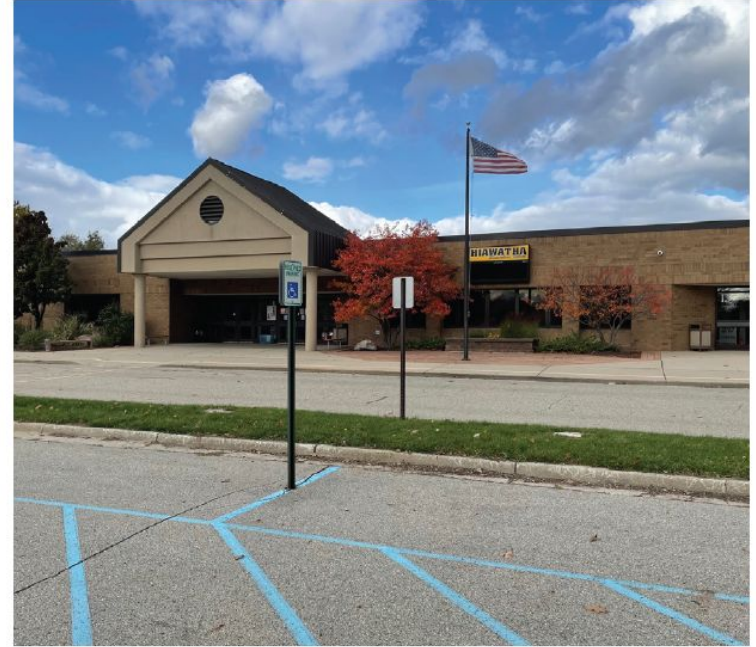
04 HIAWATHA ELEMENTARY

Use:	K-4
Built:	1988
Additions + Renovations:	n/a
Total Building Area:	62,000 SF
Site Area:	19 Acres
Enrollment:	471 students
Square Footage per Student:	131.6 sf/student
Renovation Cost:	\$11,685,587
Current Replacement Value [CRV]:	\$19,840,000
Facility Condition Index [FCI]:	59%

- Water infiltration at windows - flashing, roof leaks need attention
- Exterior doors and frames need replacement
- Carpet and ceilings need replacement, casework need repair
- Interior lighting need replacement, exterior lighting need improvements
- Replace AHUs and rebalance system

- **FCI 59%** - Minor/moderate renovations recommended to reach “good” condition - good candidate for renovation

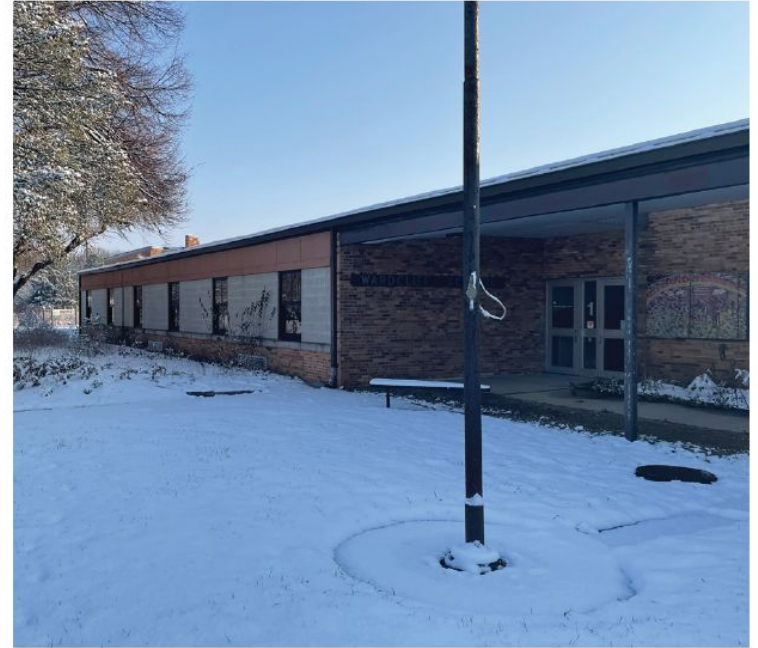
05 WARDCLIFF ELEMENTARY

Use:	Closed / Community Functions
Built:	1955
Additions + Renovations:	1967 / 1987 / 2012
Total Building Area:	33,000 SF
Site Area:	20 Acres
Enrollment:	N/A
Square Footage per Student:	N/A
Renovation Cost:	\$12,672,912
Current Replacement Value [CRV]:	\$10,560,000
Facility Condition Index [FCI]:	120%

- Need to separate bus and parent traffic, inadequate service entrance
- Exterior fascia, roof and many windows need replacement
- Complete interior upgrades needed
- Corridors narrow, office/staff support and collaboration space inadequate
- Replace lighting throughout, mechanical units and controls need replacement
- Overhead power lines to building are too low

- **FCI 120%** - Significant renovations required to reach “good” condition - not a good candidate for significant investment

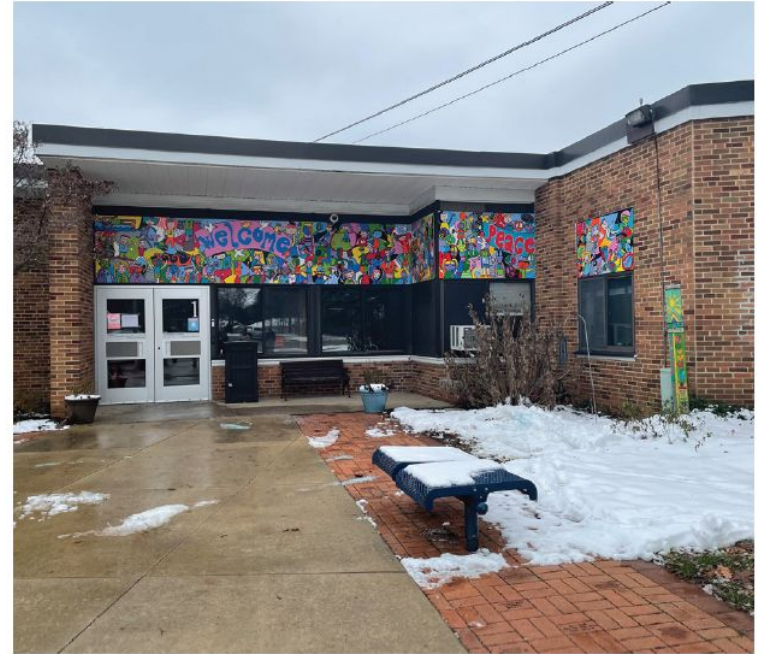
06 CENTRAL MONTESSORI / DISTRICT ADMINISTRATION

Use:	PK-4
Built:	1948
Additions + Renovations:	1963 / 1988
Total Building Area:	68,400 SF
Site Area:	28 Acres
Enrollment:	345 students
Square Footage per Student:	145.1* sf/student
Renovation Cost:	\$18,257,287
Current Replacement Value [CRV]:	\$21,888,000
Facility Condition Index [FCI]:	83%

- Crowded with circulation challenges, service access is inadequate
- Many level changes in the building, limited barrier free access
- Windows, lockers, and interior finishes need replacement
- Office space inadequate, many classrooms are small
- Lighting replacement and upgrades needed to mechanical units and controls

- **FCI 83%** - Significant renovations required to reach “good” condition - not a good candidate for significant investment
- Oldest building/will not easily accept improvements/modifications/additions
- Consider taking offline in near to mid-range

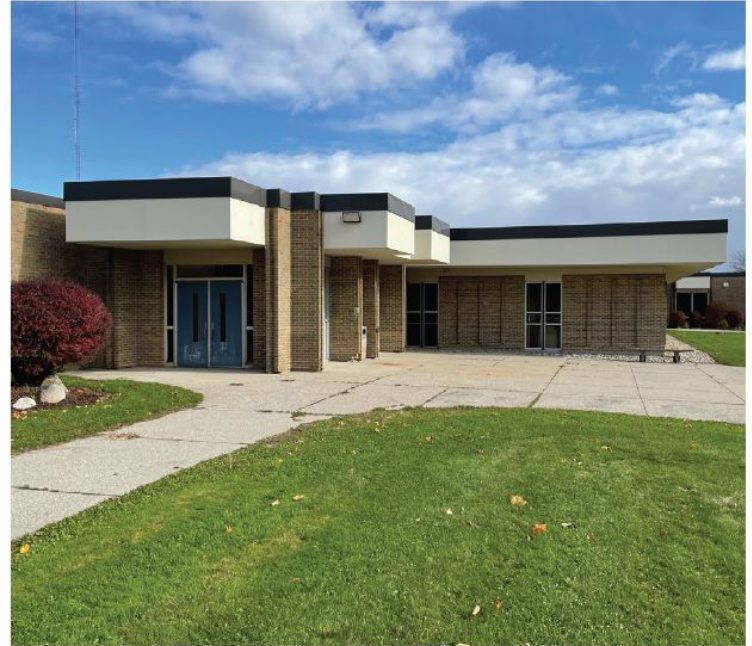
07 KINAWA 5-6 SCHOOL

Use:	5-6
Built:	1965
Additions + Renovations:	1967 / 1994 / 1996 / 2006
Total Building Area:	154,000 SF
Site Area:	72 Acres
Enrollment:	644 students
Square Footage per Student:	239.1 sf/student
Renovation Cost:	\$41,242,872
Current Replacement Value [CRV]:	\$50,050,000
Facility Condition Index [FCI]:	82%

- Pavement, loading dock, tennis courts need replacement
- Stormwater improvements necessary
- Many level changes present barrier-free challenges
- Office space inadequate, poor visibility to the main entrance
- Ceilings, flooring and casework need replacement
- Unused pool at center of building needs to be addressed
- Mechanical and electrical upgrades needed throughout

- **FCI 82%** - Significant renovations required to reach “good” condition - not a good candidate for significant investment; aging infrastructure, difficult accessibility

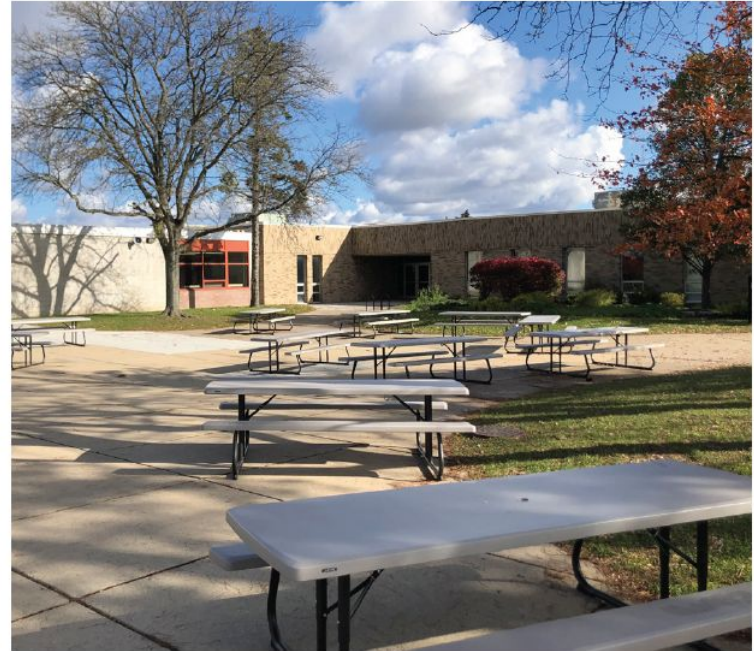
08 CHIPPEWA 7-8 SCHOOL

Use:	7-8
Built:	1958
Additions + Renovations:	1963 / 1966 / 1977 / 1995
Total Building Area:	196,000 SF
Site Area:	78 Acres
Enrollment:	712 students
Square Footage per Student:	275.3 sf/student
Renovation Cost:	\$58,909,697
Current Replacement Value [CRV]:	\$63,700,000
Facility Condition Index [FCI]:	92%

- Sidewalks poor, vehicular circulation conflicts, athletic field structures need replacement; athletic wing recently renovated, in good condition
- Fine Arts wing in poor condition, space is inefficient
- Main entrance not well defined
- Flooring, ceilings, and lockers need replacement throughout
- Selective mechanical replacements and electrical service need upgrade

- **FCI 92%** - Significant renovations required to reach “good” condition - not a good candidate for significant investment ; some portions in better condition/advantageous others past useful life/not set up for 21st Century

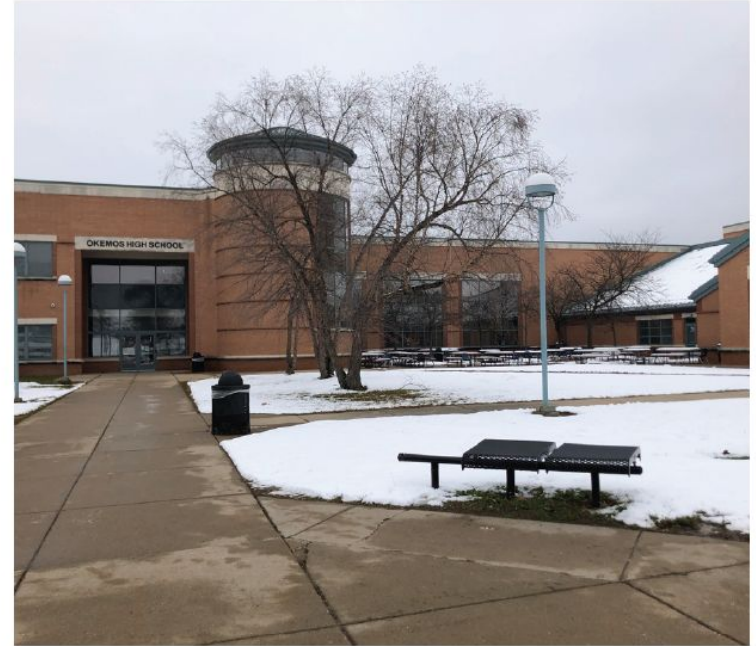
09 OKEMOS HIGH SCHOOL

Use:	9-12
Built:	1994
Additions + Renovations:	2015
Total Building Area:	320,000 SF
Site Area:	96 Acres
Enrollment:	1,457 students
Square Footage per Student:	219.6 sf/student
Renovation Cost:	\$44,299,036
Current Replacement Value [CRV]:	\$107,200,000
Facility Condition Index [FCI]:	41%

- Drainage issues around building and site circulation to be addressed
- Main entrance is not well defined, poor visibility from office
- Fine Arts support spaces are inadequate
- Replace carpet and VCT throughout
- Mechanical equipment at end of life, electrical service upgrade, lighting replacement throughout

- FCI 41% - Minor/moderate renovations recommended to reach “good” condition - good candidate for renovations; relatively young building

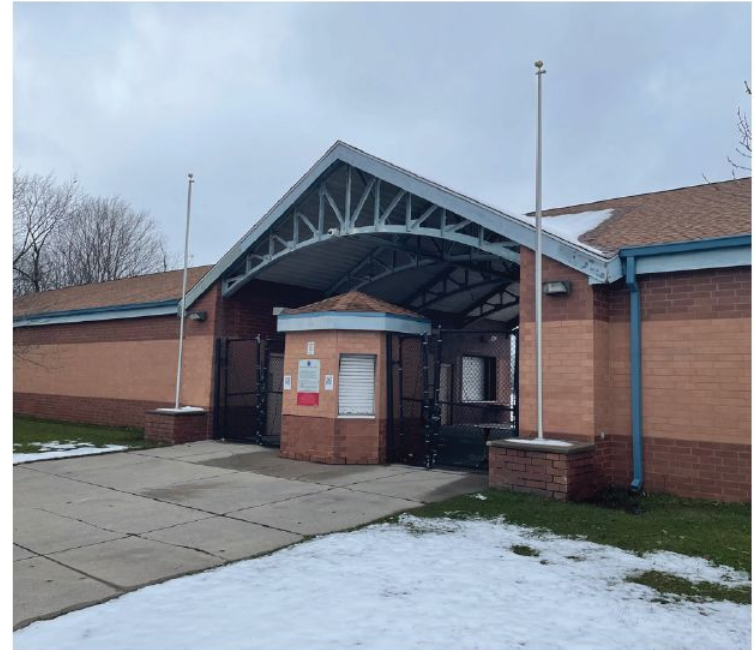
10 OKEMOS HIGH ATHLETICS

Use:	District Athletics
Built:	1995
Additions + Renovations:	N/A
Total Building Area:	9,600 SF
Site Area:	23 Acres
Enrollment:	N/A
Square Footage per Student:	N/A
Renovation Cost:	\$8,950,347
Current Replacement Value [CRV]:	N/A
Facility Condition Index [FCI]:	N/A

- Barrier free access to softball and baseball fields inadequate
- Pavement (adjacent to football field) and fencing need replacement
- Ticket Booth brick repairs and gate need replacement
- Flooring, ceilings and lighting in locker rooms need replacement
- Pressbox updates recommended

- Athletic complex has strengths and some improvement needs
- Needs do not rise to the level of exploring complete replacement or relocation
- Although some components require improvement, not advisable to substantially change location of various athletic courts and fields

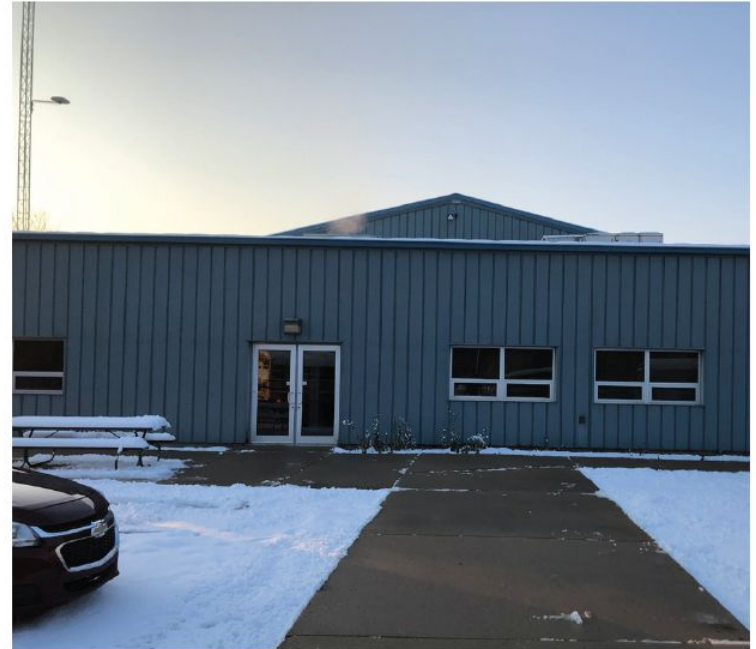
11 TRANSPORTATION BUILDING

Use:	Bus Service + Transportation
Built:	1993
Additions + Renovations:	N/A
Total Building Area:	8,000 SF
Site Area:	15 Acres
Enrollment:	N/A
Square Footage per Student:	N/A
Renovation Cost:	\$1,456,711
Current Replacement Value [CRV]:	\$2,000,000
Facility Condition Index [FCI]:	73%

- No barrier free access at main entrance
- Metal siding and structure rusting at base of building
- Hollow metal doors and frames to be replaced
- VCT, carpet, and ceilings to be replaced
- Trench drain to be added in shop, overhead doors to be replaced
- Mechanical controls to be addressed, lighting to be replaced

- **FCI 73%** - Minor/moderate renovations recommended to bring to “good” condition - good candidate for renovations

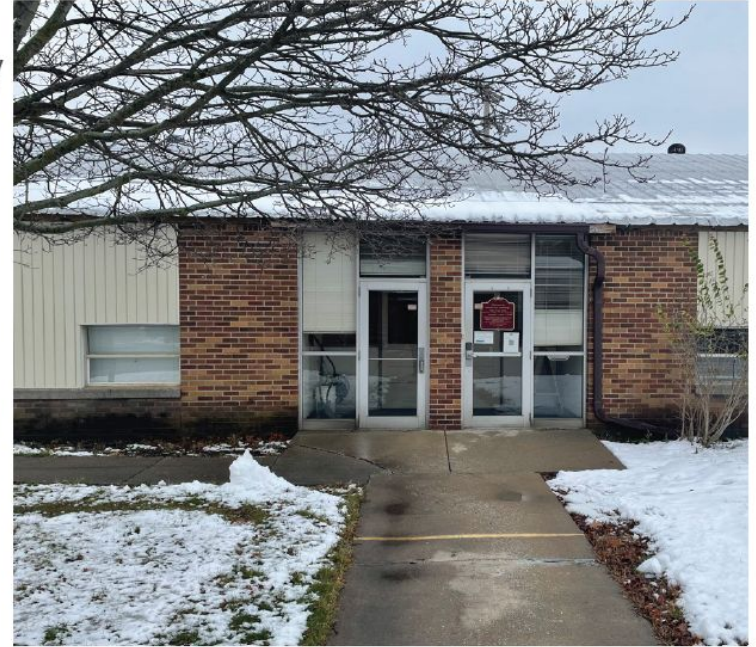
12 DISTRICT OPERATIONS

Use:	Operations / Technology Maintenance
Built:	1975
Additions + Renovations:	N/A
Total Building Area:	6,000 SF / Building
Site Area:	East of Administration Building
Enrollment:	N/A
Square Footage per Student:	N/A
Renovation Cost:	\$5,930,892
Current Replacement Value [CRV]:	\$4,500,000
Facility Condition Index [FCI]:	132%

- Site is tight, access is difficult with school traffic
- The three buildings are in poor condition
- Doors, windows, and roofs need replacement
- Carpet, ceilings, casework and toilet rooms need replacement
- Mechanical systems fed from tunnel to Admin building,
- Lighting replacement needed throughout

- **FCI 132%** - Significant renovations required to bring to “good” condition; not good candidates for significant investment

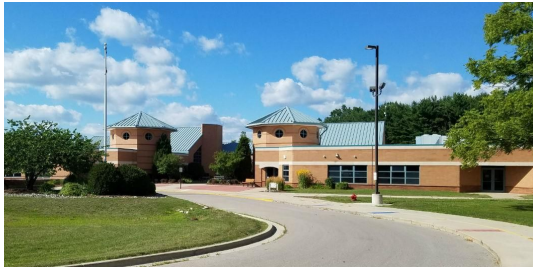
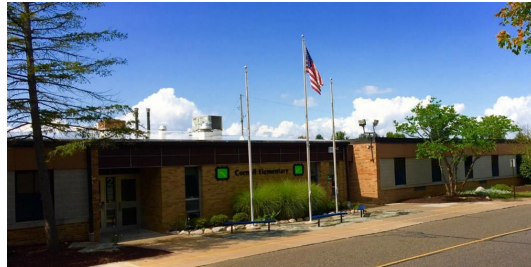
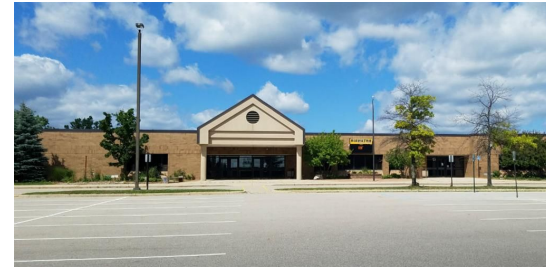
Elementary Schools - Feedback Consistent

- Need Much More Space (Elementaries Are Over Capacity)
- Need Small Group Rooms, Itinerant Offices, Bathrooms
- Need New Student Furniture
- Address Traffic Flow + Car Drop Off Lines (Safety + Capacity)
- Replace Playgrounds, Casework, Carpet, Ceiling Tiles, HVAC, Lighting
- Desire Permanent Walls Between Classrooms for Acoustics

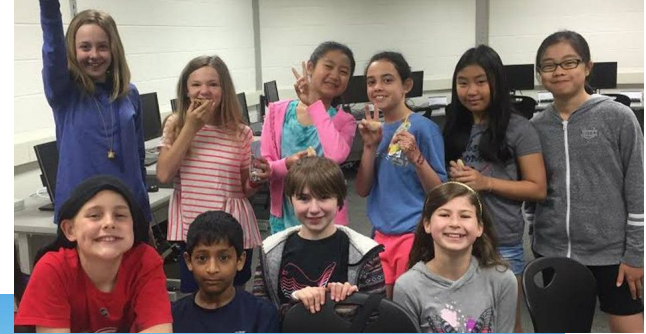
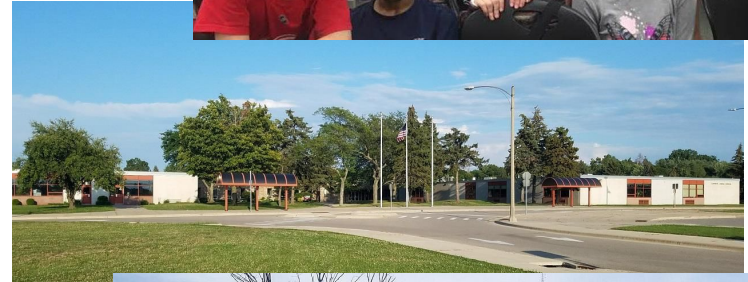
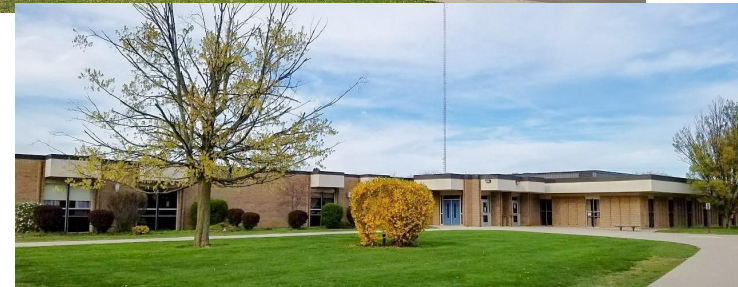
Chippewa + Kinawa Middle Schools

- Need New Student Furniture
- Cafeteria Not Big Enough
- Many Classrooms Without Windows
- Pool Needs to be Filled In
- Need Small Group Rooms, Itinerant Offices, Bathrooms
- Address Traffic Flow + Car Drop Off Lines (Safety + Capacity)
- Replace Playgrounds, Casework, Carpet, Ceiling Tiles, HVAC, Lighting
- Concrete Heaving, Accessibility Concerns

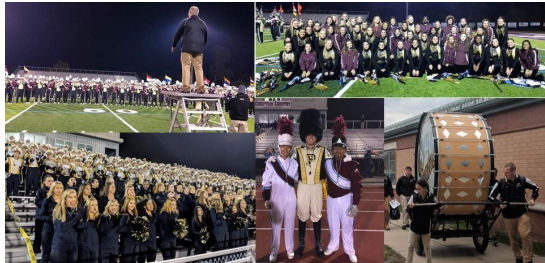
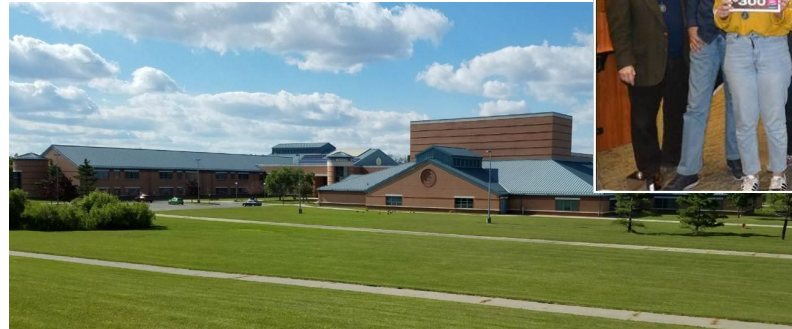
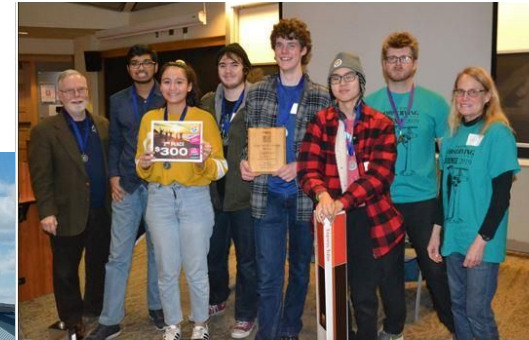
Okemos High School

- Need New Student Furniture
- Need Additional Pool Space (More Lanes + Diving)
- Need Larger Fine Arts Spaces (More Capacity for Band, Orchestra, Choir)
- Need Additional Athletic Spaces (Kids Practicing Until 10:00pm)
- Athletic Fields Need Drainage + Restrooms
- Tennis Court Needs to be Redone
